Manhole Inspection Summary

Manhole # S17EE1027MH

Insp Date: 1/11/07 2:07 PM

Location Address: **3812 GREENSPRING AVE**

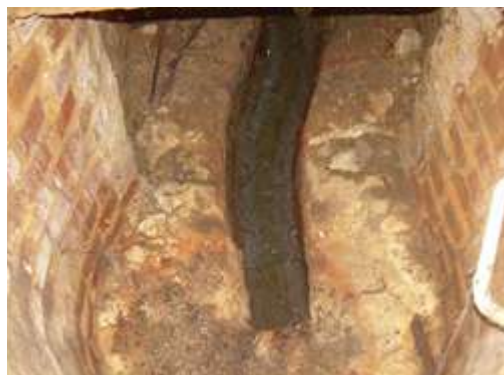
Top View

Bench debris.

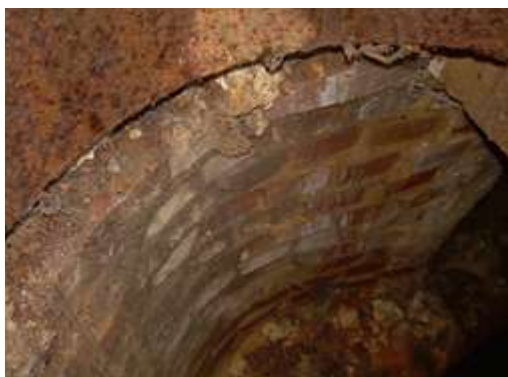
Defect

Corbel deterioration and infiltration.

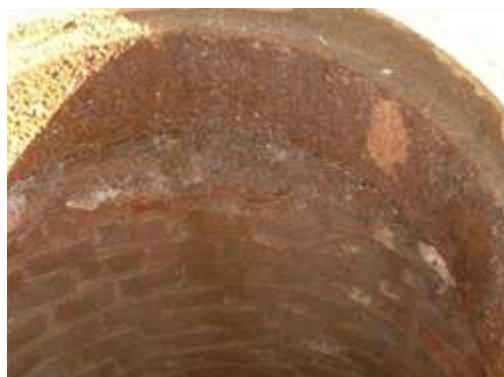
Defect

Corbel deterioration and infiltration.

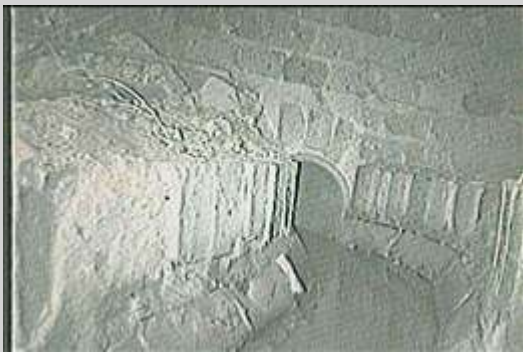
8 in. Circular Gravity Sewer Pipe Out @ 12 O'Clock

Infiltration: **None** Pipe Seal Cond: **Sound**

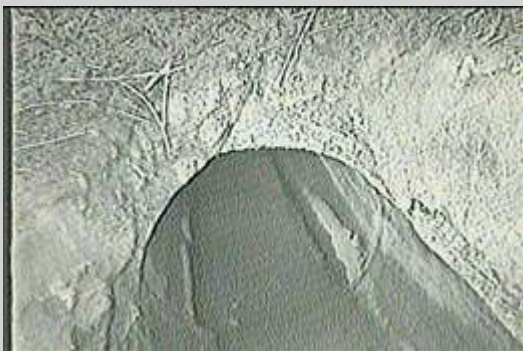
8 in. Circular Gravity Sewer Pipe In @ 7 O'Clock

Infiltration: **Evidence** Pipe Seal Cond: **Cracked**
